PROJECT OVERVIEW

INNOX was appointed by MJS Projects to undertake a comprehensive programme of licensed and non-notifiable asbestos removal within Norwich Building at City College Norwich. This formed a critical part of the college's wider refurbishment works aimed at modernising and upgrading several teaching spaces. Pre-construction surveys identified a significant presence of asbestos-containing materials that required controlled removal before refurbishment could begin.

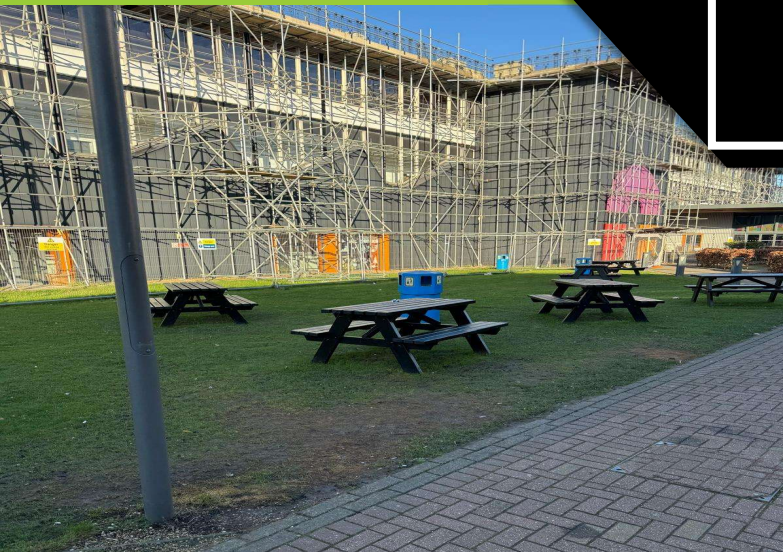
City College Norwich Enclosure Floor C

- CCTV x8
- NPU (4000cmh) x3
- Waste route 45m
- Exhaust ducting 0m
- Type H vacuum
- Transit route 45m
- AIB
- Wheellie Bin x2
- Airlock and Baglock 1x1x2m
- Air inlet pod 1x1x2m x2
- X4 VP = min 600x300mm visible area
- Enclosure 3.2m H with 0.3 void
